Request for Services (RFS) #25-50
Owner's Project Management Services
Robbins Memorial Town Hall - Exterior Restoration

ADDENDUM NO. 1

**ARLINGTON TOWN HALL CUPOLA DEMOLITION
MEMO – 15 September 2023**

Structural Condition Assessment on Arlington Town Hall Cupola Arlington, Massachusetts

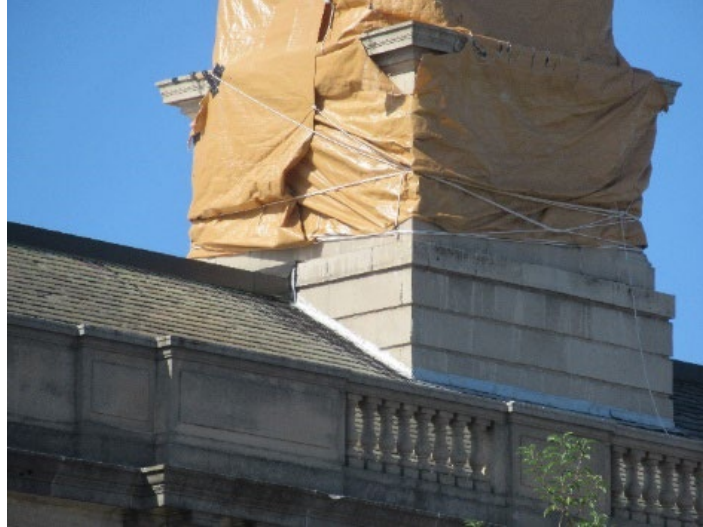
The cupola spans two types of roof systems. At the front, along Massachusetts Ave, the base is set into a pitched slate shingle roofing system. The age is unknown. The shingles appear to be intact, and there is roofing mastic and parging that has been added to the joint between the base between roof and the terra cotta blocks.

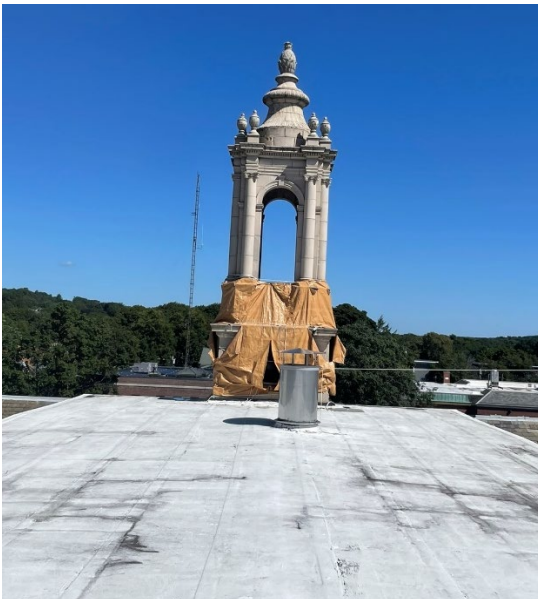
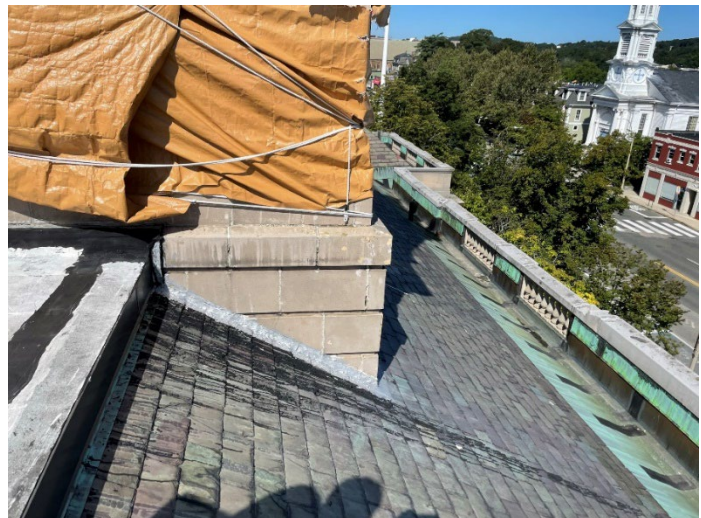
The rear section of the cupola is set into a flat roof system that is topped with a black (painted white) EPDM membrane. The EPDM membrane was likely a reroof of a tar and gravel system. CTX has recommended to the Owner to have the roofing materials, including mastics and flashings, tested for asbestos-containing materials (ACM), prior to demolition of the tower and preferably before bidding. The front edge of the membrane appears to have a coping that is either aluminum or lead-coated copper. Further exploration of that material will be done prior to bidding.

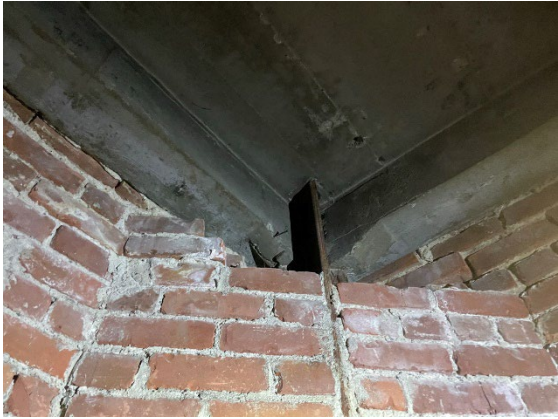
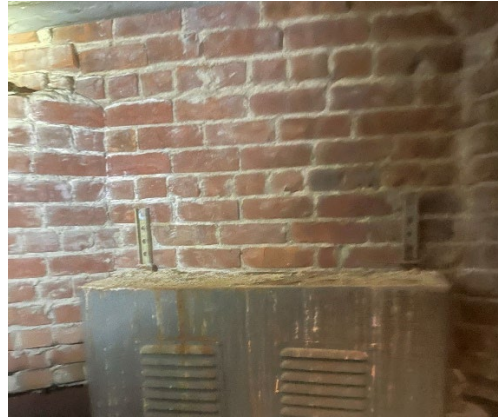
The brick at the base shows minimal efflorescence and remains in reasonably good structural condition. Our structural engineer has recommended that we not disturb this structure because of its proximity to the steel beams and existing wood roof framing.

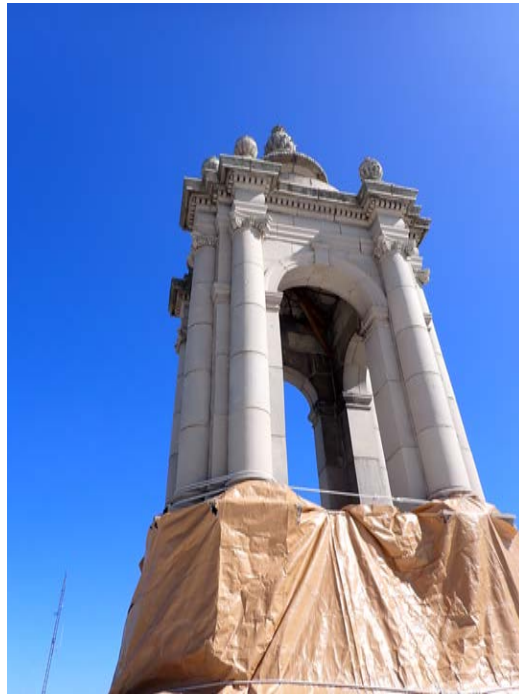
The terra cotta above the podium and balustrade is in good to fair condition. (Fig. 1) There is some isolated glaze failure and cracks in the units, but there are many elements that are in good condition. (Fig. 2) The podium level to the roof is in poor condition with extensive glaze loss, clay body deterioration and cracking. The podium base is wrapped in tarps and was not fully visible for review. (Fig. 3) The urn on the northwest corner has a large crack through the entire height of the unit. Other cracks were observed on the belt courses and corners of the cupola. (Fig. 4)

Figure 1. Cupola above podium.

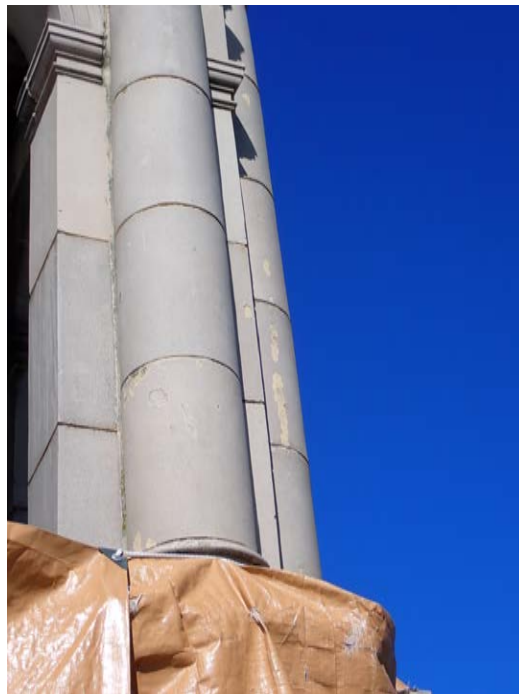
Figure 2. Terra cotta typical conditions with glaze loss.

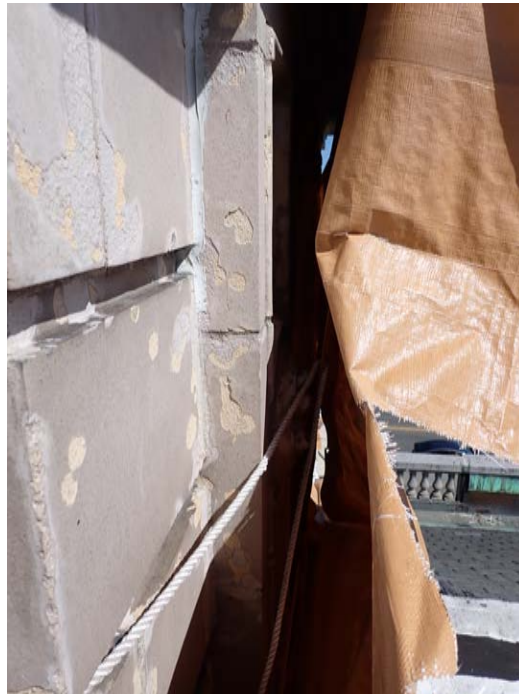
Figure 3. Podium level behind tarp showing extensive glaze failure.

While the terra cotta units *could* be restored, the underlying rusting steel will continue to expand and damage the terra cotta façade, making restoration a short term solution that is not recommended.

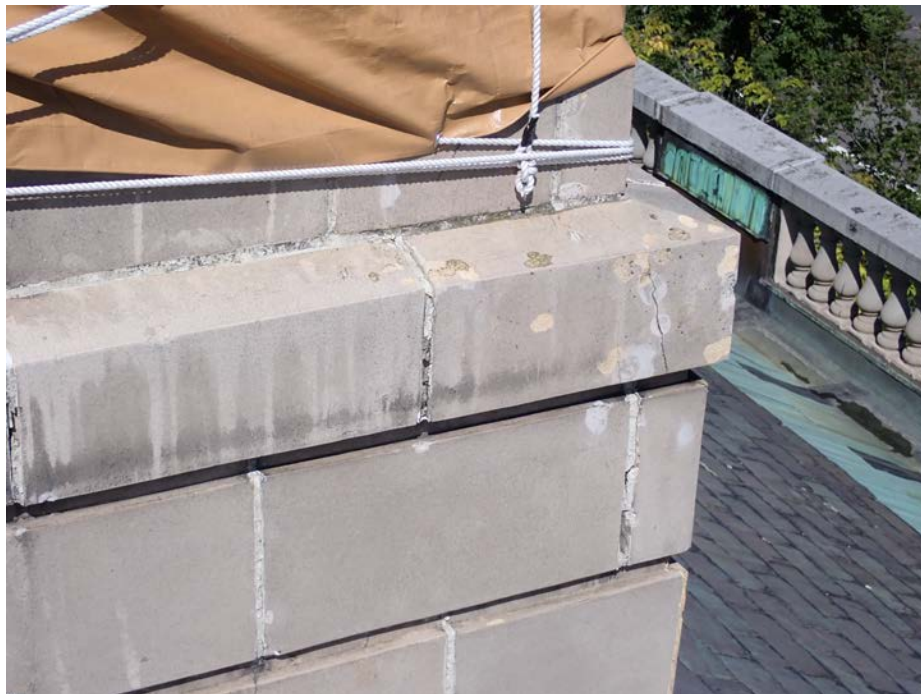
Figure 4. Lower podium at front of cupola showing mortar failure, glaze failure and crack through terra cotta.

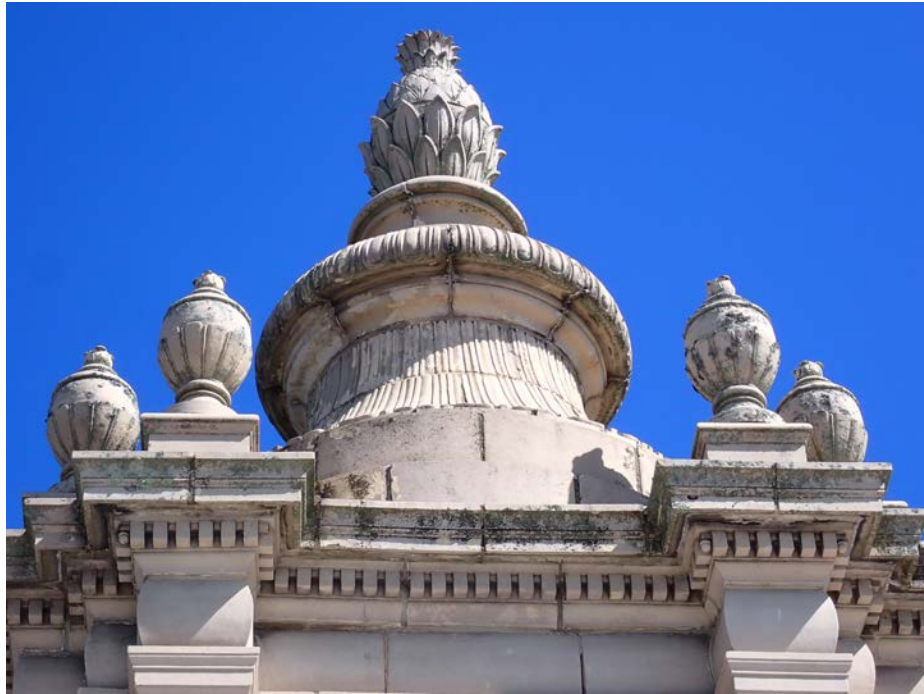
Figure 5. Upper cupola showing final and decorative units between finial and drum.

1. Finial (Fig. 5)
2. Decorative units between finial and drum
3. Urns (Fig. 5)
4. Elements of entire cornice from column capitals to urns. Remove one unit from each level to get representative molding profiles at each level. (Fig. 6)
5. Capitals (Fig. 6)
6. Keystone at arch
7. Arch unit for profile
8. Pilaster capitals
9. Column base
10. Balustrade cap
11. Baluster
12. Half round detail at base of baluster piers
13. Band course above clock
14. Rosettes at clock level (Fig. 7)

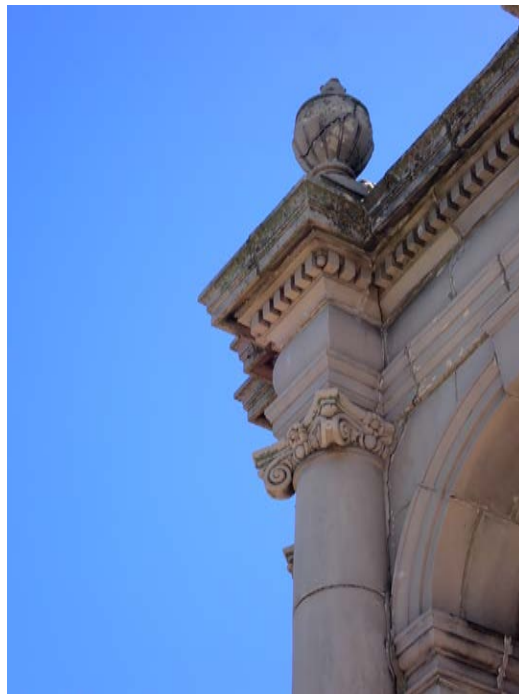
Figure 6. Upper cupola cornice elements and capital.

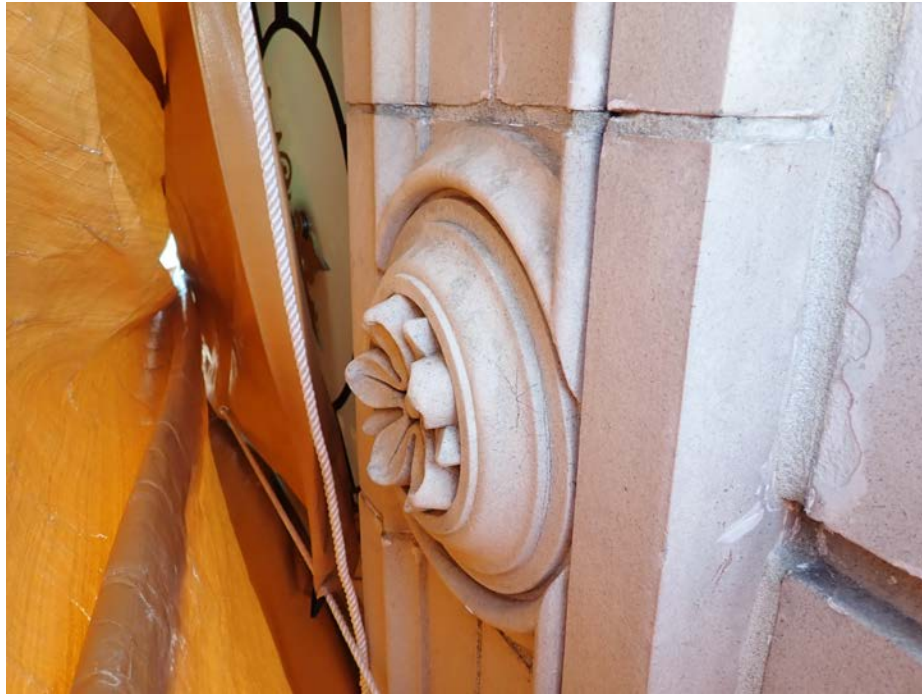
Figure 7. Decorative rosette at clock level.

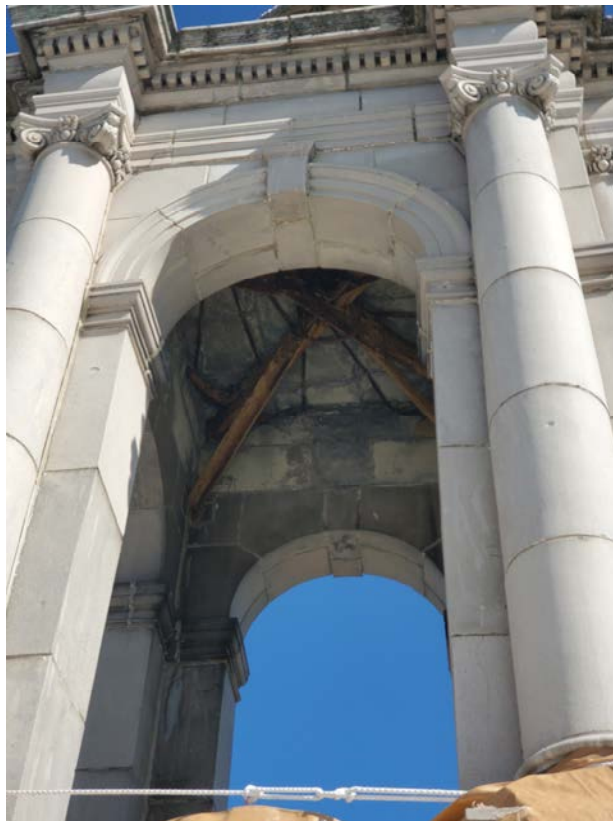
Photo 2.

The cupola structure is deteriorated with notable cracking of the terracotta elements on each exterior face of the structure as well as cracking at the interior corners. See photo 2. Cracks have been repaired and reopened. The structure has a slight visible lean but it is unclear if this was the as-built condition. We gained access to the cupola interior through one of the clock faces. The interior clock face level is constructed with terracotta block filled with grout. The concrete at the base of the belfry has spalled revealing a severely corroded interior steel member. See photo 3. From the clock face room we were able to enter the existing roof structure through an opening in the floor. Below the cupola are brick masonry walls supported on steel beams. The brick masonry walls have step cracks and the mortar is deteriorated. See photo 4. At the corners steel columns can be seen embedded within the masonry. The steel columns extend from the supporting steel within the roof to the steel supporting the belfry framing. The embedded column has corrosion but does not appear to have significant section loss at visible locations. See photo 5. Photos 6 and 7 show the condition of the steel supporting structure. While the top flange of the beams show signs of deterioration due to water the majority of the sections are in good condition. Connections do not show signs of rust. Photo 6 shows part of the connecting angle is missing, however, the edge was painted so the damage was sustained prior to the last paint coat possibly dating back to installation of the beams.

R&G recommends removal of the existing cupola to prevent further damage due to water infiltration. The existing structure should be taken down to the brick walls at roof level. Existing drawings show wood framing being supported off the brick masonry walls. Brick masonry is to be repointed and wood framing to be inspected for signs of deterioration. The top of the brick masonry walls should be braced internally during removal of the cupola and until new roof framing is installed. Existing steel beams should be wire brushed cleaned and painted to prevent further deterioration.

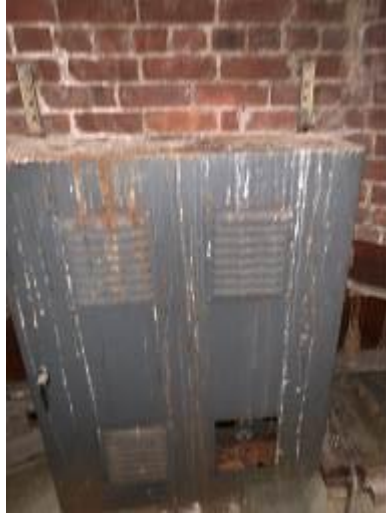
Obsolete Control

Clock controller is located in the lower tower. There is an obsolete clock controller abandoned on the west wall of the lower tower.

All wiring devices, conduit, junction boxes, fittings and wiring to be made safe and removed complete for the removal of the clock tower.

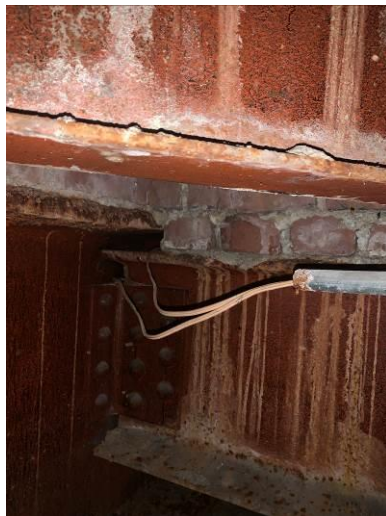
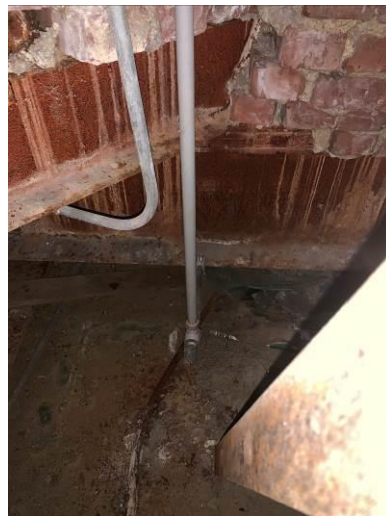
Conduit and Wiring at Lower Tower

There is lighting and power in the clock tower which comes from (3)- 20A/1P circuit breakers in a panel located on the floor below in the clerk's office power panel. There is a receptacle in a weatherproof enclosure and (3) LED light fixtures. All conduit and junction boxes in the upper tower is PVC and flexible liquid tight conduit.
