Request for Services (RFS) #25-50
Owner's Project Management Services
Robbins Memorial Town Hall - Exterior Restoration

ADDENDUM NO. 1

**ARLINGTON TOWN HALL CUPOLA DEMOLITION
MEMO – 15 September 2023**

Structural Condition Assessment on Arlington Town Hall Cupola Arlington, Massachusetts

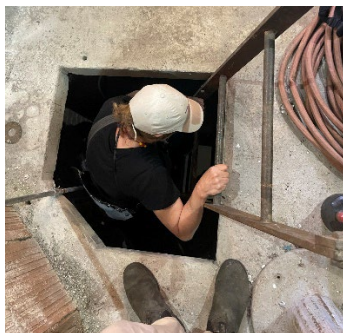
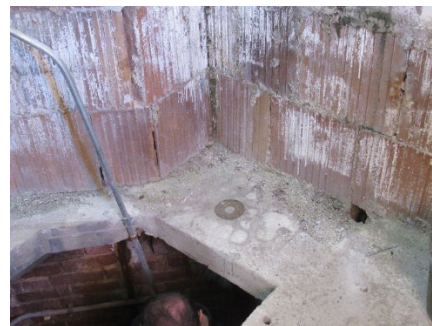
The cupola is currently wrapped in a plastic tarp at its podium post to minimize further leaking inside the building and deterioration of the terra cotta blocks of the clock tower. The base of the tower is constructed of brick and terra cotta face blocks that are sitting on a steel beam structure. That structure is separated from the cupola structure by a concrete platform with a relatively small interior opening that allows access below on a fixed metal ladder to a brick plinth base. White efflorescence on the terracotta and concrete show the extent of water penetration. The concrete deck is currently tarped over to prevent further water migration below.

The clock tower should be removed to the concrete slab that sits on the brick base. An insulated membrane roof (EPDM to match existing) will cover the existing deck and flashed at the edges per industry standards to seal the joint with the existing roof systems and prevent further moisture penetration into the building. The existing access hole in the concrete slab will be covered by a lightweight roof hatch to allow Owner access to the space below. The terracotta will be documented by a laser scan, and several representative pieces of the terracotta will be salvaged during the tower demolition and stored for future use in the rebuilding phase.

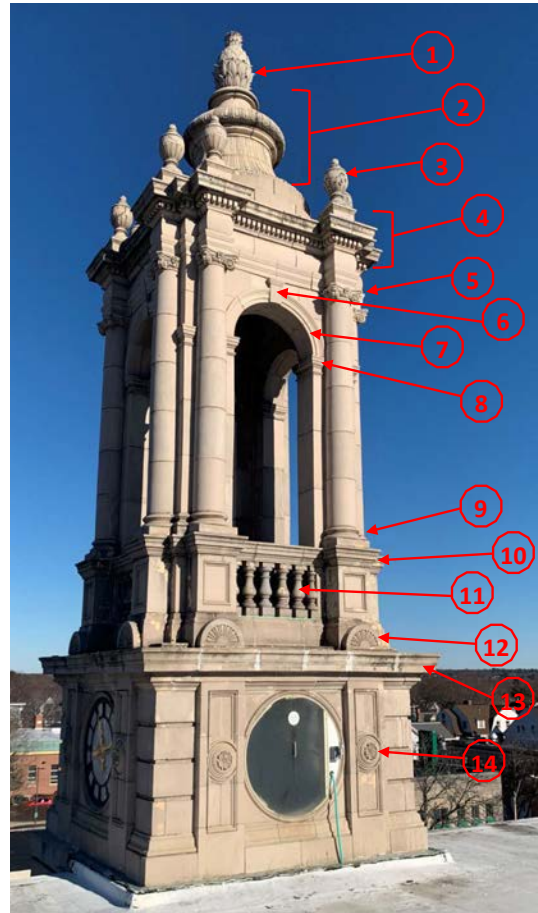
1. Finial (Fig. 5)
2. Decorative units between finial and drum
3. Urns (Fig. 5)
4. Elements of entire cornice from column capitals to urns. Remove one unit from each level to get representative molding profiles at each level. (Fig. 6)
5. Capitals (Fig. 6)
6. Keystone at arch
7. Arch unit for profile
8. Pilaster capitals
9. Column base
10. Balustrade cap
11. Baluster
12. Half round detail at base of baluster piers
13. Band course above clock
14. Rosettes at clock level (Fig. 7)

There are intact decorative elements that can be salvaged for replication. Removal and retention of representative units for replication will help with accurate replication no matter what material is used to fabricate the new units. The following elements are recommended for salvage:

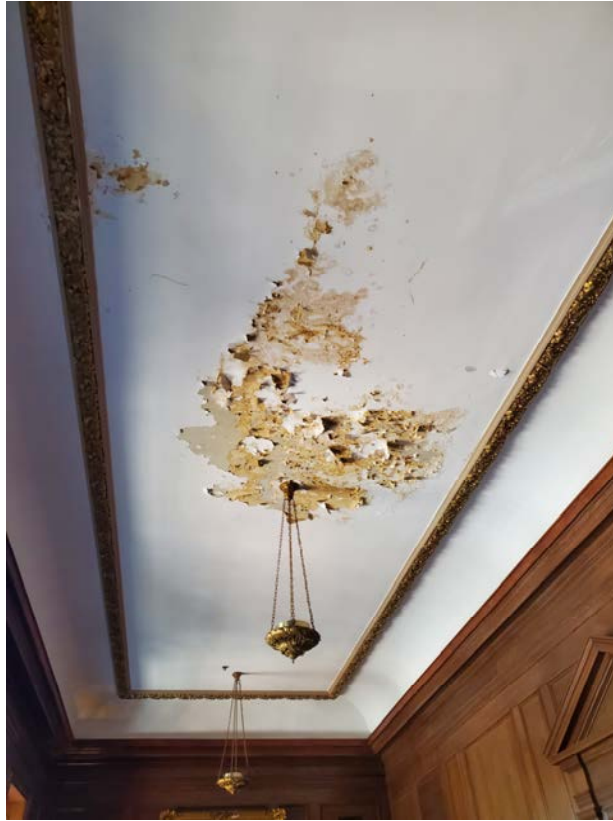
On August 23, 2023, R&G was asked to review the condition of the existing cupola and supporting elements. The Arlington town hall building was built in 1913. The copula has an internal steel supporting structure with concrete floor levels at the base of the belfry and the base of the clock room. The rest of the cupola is constructed with terracotta. The entire structure is supported on brick masonry walls stacked on top of existing steel beams within the roof structure. Previous reports completed on the condition of the cupola have noted significant cracking of the terracotta and masonry and also noted the cupola structure is not plumb. The cupola is the source of extensive water leaks in the building which has caused damage to the Lyon's room seen in Photo 1. Attempts were made to wrap the cupola to prevent excessive water infiltration by wrapping the clock face level with tarps.

R&G recommends removal of the existing cupola to prevent further damage due to water infiltration. The existing structure should be taken down to the brick walls at roof level. Existing drawings show wood framing being supported off the brick masonry walls. Brick masonry is to be repointed and wood framing to be inspected for signs of deterioration. The top of the brick masonry walls should be braced internally during removal of the cupola and until new roof framing is installed. Existing steel beams should be wire brushed cleaned and painted to prevent further deterioration.

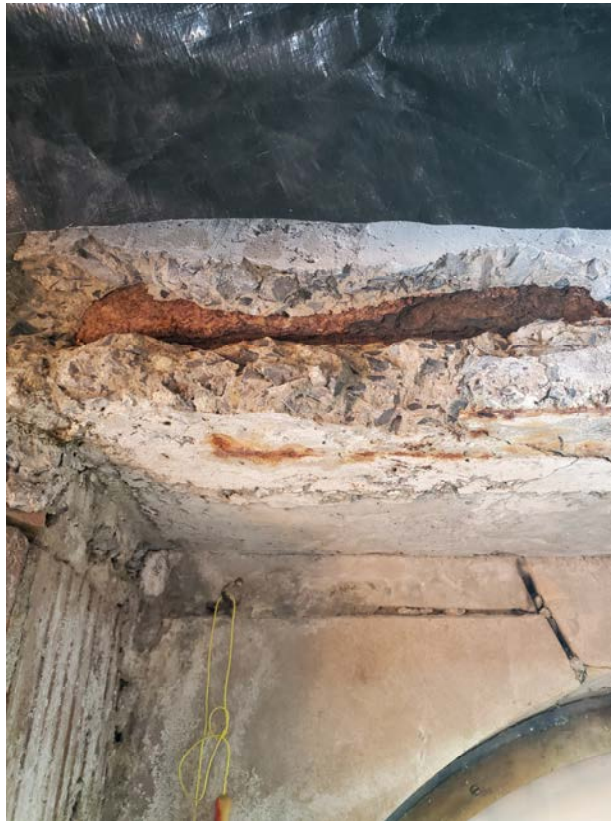
Photo 3.

The cupola structure is deteriorated with notable cracking of the terracotta elements on each exterior face of the structure as well as cracking at the interior corners. See photo 2. Cracks have been repaired and reopened. The structure has a slight visible lean but it is unclear if this was the as-built condition. We gained access to the cupola interior through one of the clock faces. The interior clock face level is constructed with terracotta block filled with grout. The concrete at the base of the belfry has spalled revealing a severely corroded interior steel member. See photo 3. From the clock face room we were able to enter the existing roof structure through an opening in the floor. Below the cupola are brick masonry walls supported on steel beams. The brick masonry walls have step cracks and the mortar is deteriorated. See photo 4. At the corners steel columns can be seen embedded within the masonry. The steel columns extend from the supporting steel within the roof to the steel supporting the belfry framing. The embedded column has corrosion but does not appear to have significant section loss at visible locations. See photo 5. Photos 6 and 7 show the condition of the steel supporting structure. While the top flange of the beams show signs of deterioration due to water the majority of the sections are in good condition. Connections do not show signs of rust. Photo 6 shows part of the connecting angle is missing, however, the edge was painted so the damage was sustained prior to the last paint coat possibly dating back to installation of the beams.

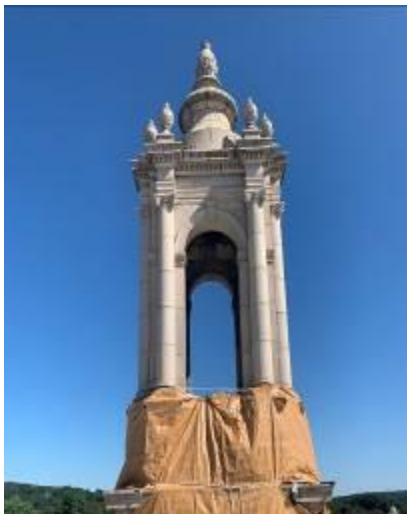
Clock Tower

There is lighting and power in the clock tower which comes from (3)- 20A/1P circuit breakers in a panel located on the floor below in the clerk's office power panel. There is a receptacle in a weatherproof enclosure and (3) LED light fixtures. All conduit and junction boxes in the upper tower is PVC and flexible liquid tight conduit.

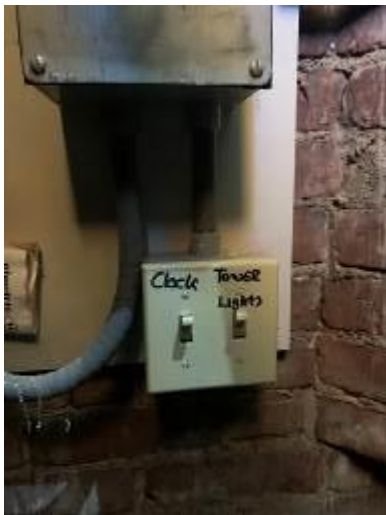
Switch Control in Lower Tower

The light in the clock tower is LED in the upper and a keyless porcelain socket in the lower tower. The lights are controlled by local switches and via a photo cell located on the Southeast corner of the tower.

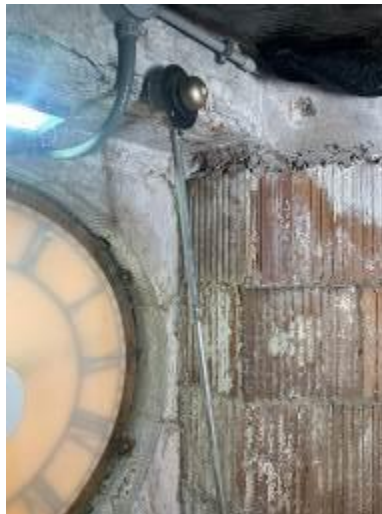
Heat Detector

There is a fixed temperature heat detector in the upper tower. It is fed with EMT conduit.
