**Report of the Transportation Advisory Committee
to the
Arlington Board of Selectmen**

11 July, 2005

Dallin School

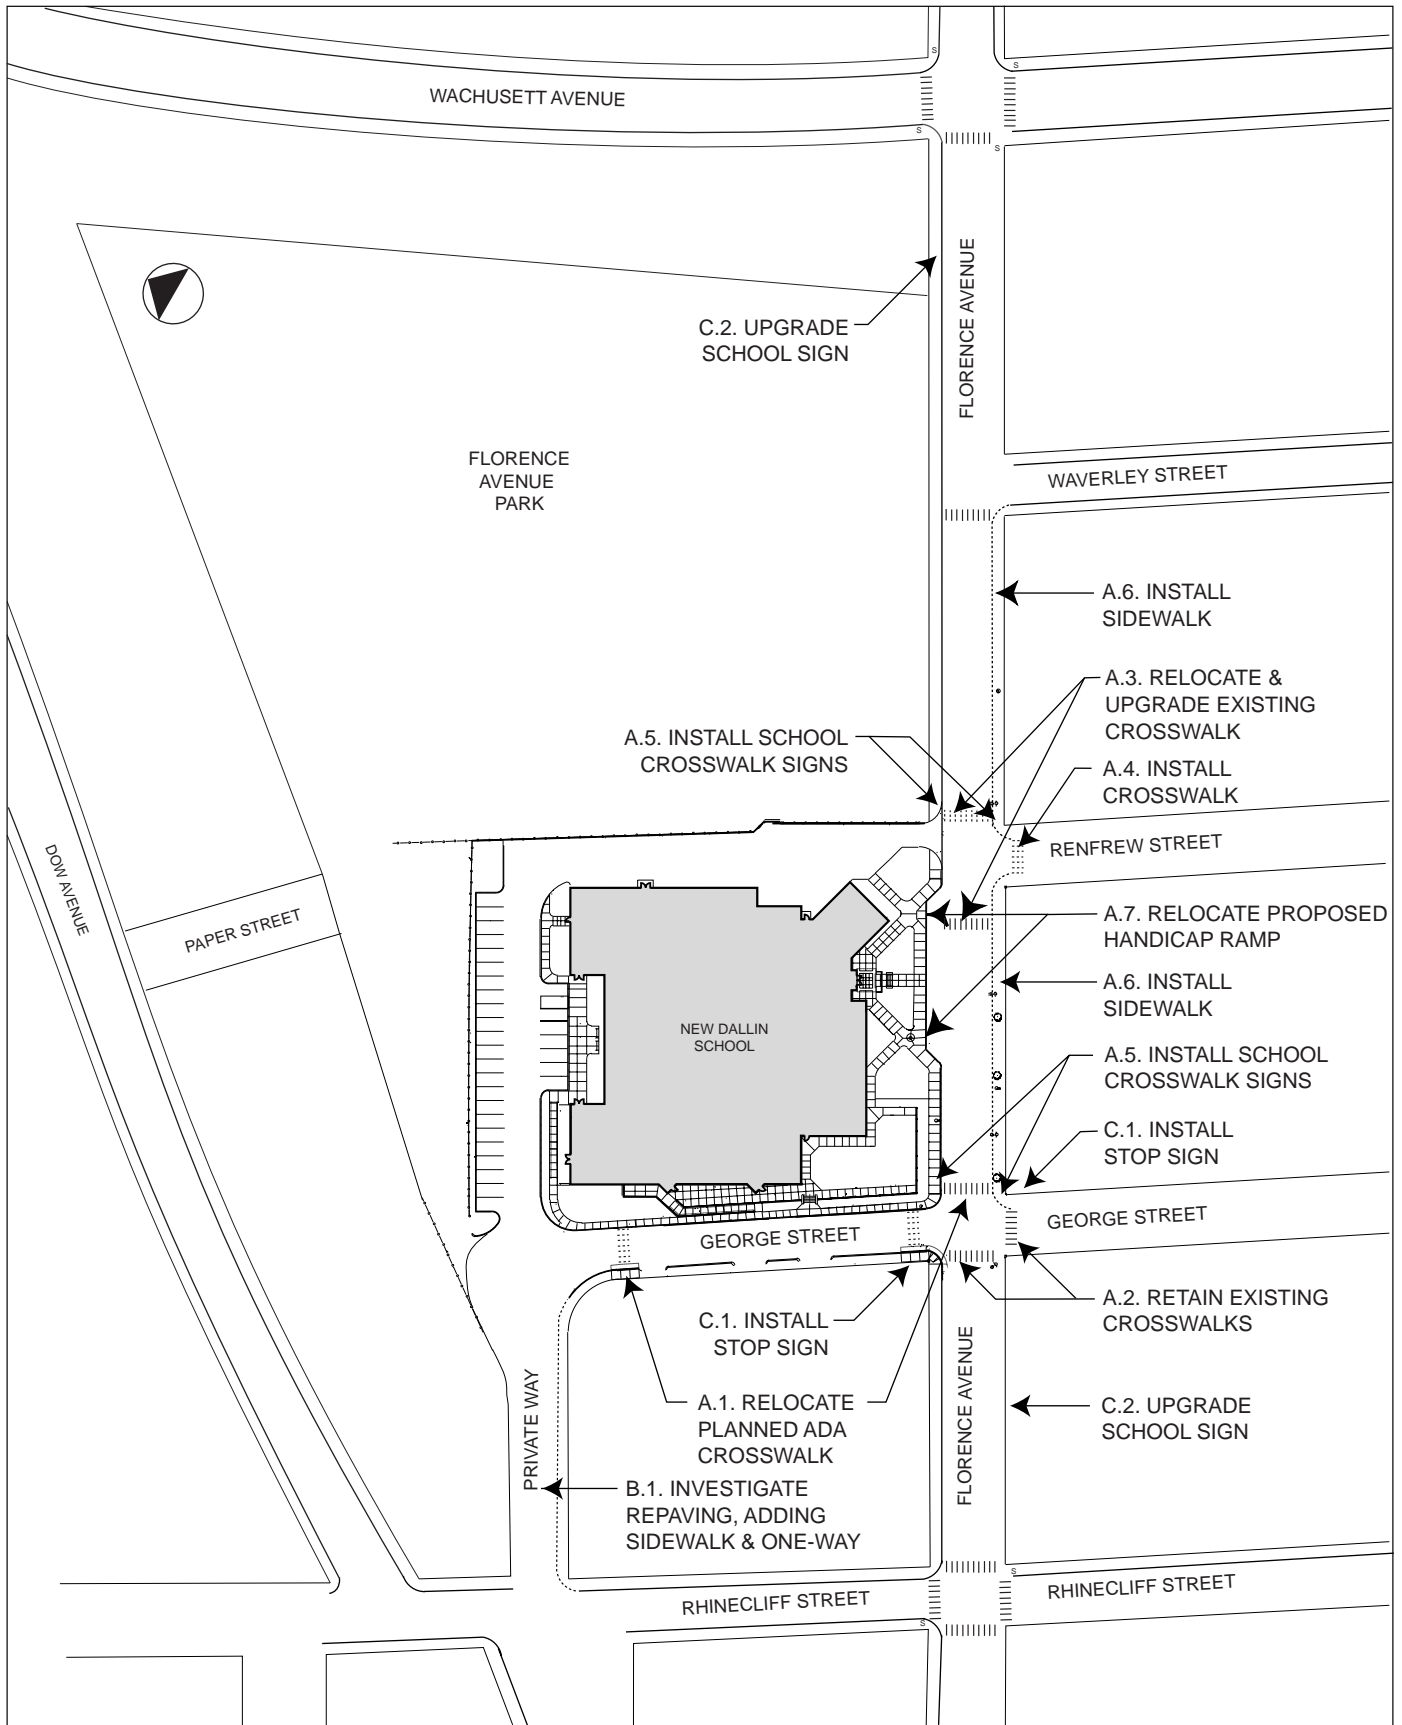
Figure 1 Dallin School Safety Recommendations

Figure 1 illustrates the recommended items in the immediate neighborhood of the school.

- A.1. Relocate the planned ADA compliant crosswalk from the north end of George Street to Florence Avenue at George Street adjacent to the Dallin School. (This crosswalk is planned and budgeted as part of the Dallin rebuild project.)

- A.4. Install a crosswalk on Renfrew Street at Florence Avenue.
- A.5. Install school crosswalk signs in each direction on the Florence Avenue crosswalks at the east side of George Street and at Renfrew Street.

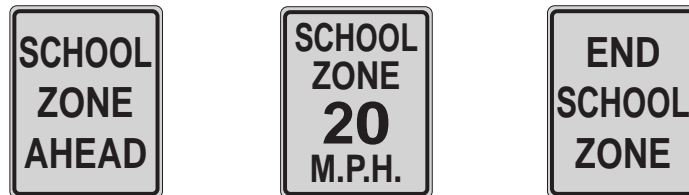
The creation of a School Zone for the Dallin School could also be considered by the Town. Arlington currently has two School Zones, at the Brackett and the Peirce Schools. A School Zone could either be outfitted with flashing signs, as with the Brackett and Peirce, or with standard signs similar to those shown below. These signs would replace the signs in recommendation C.2. above and would likely encompass a slightly different section of Florence Avenue.

Figure 3 Possible School Zone Signs

Recommendation C.3. Investigate creating a School Zone with speed limits for the Dallin School.

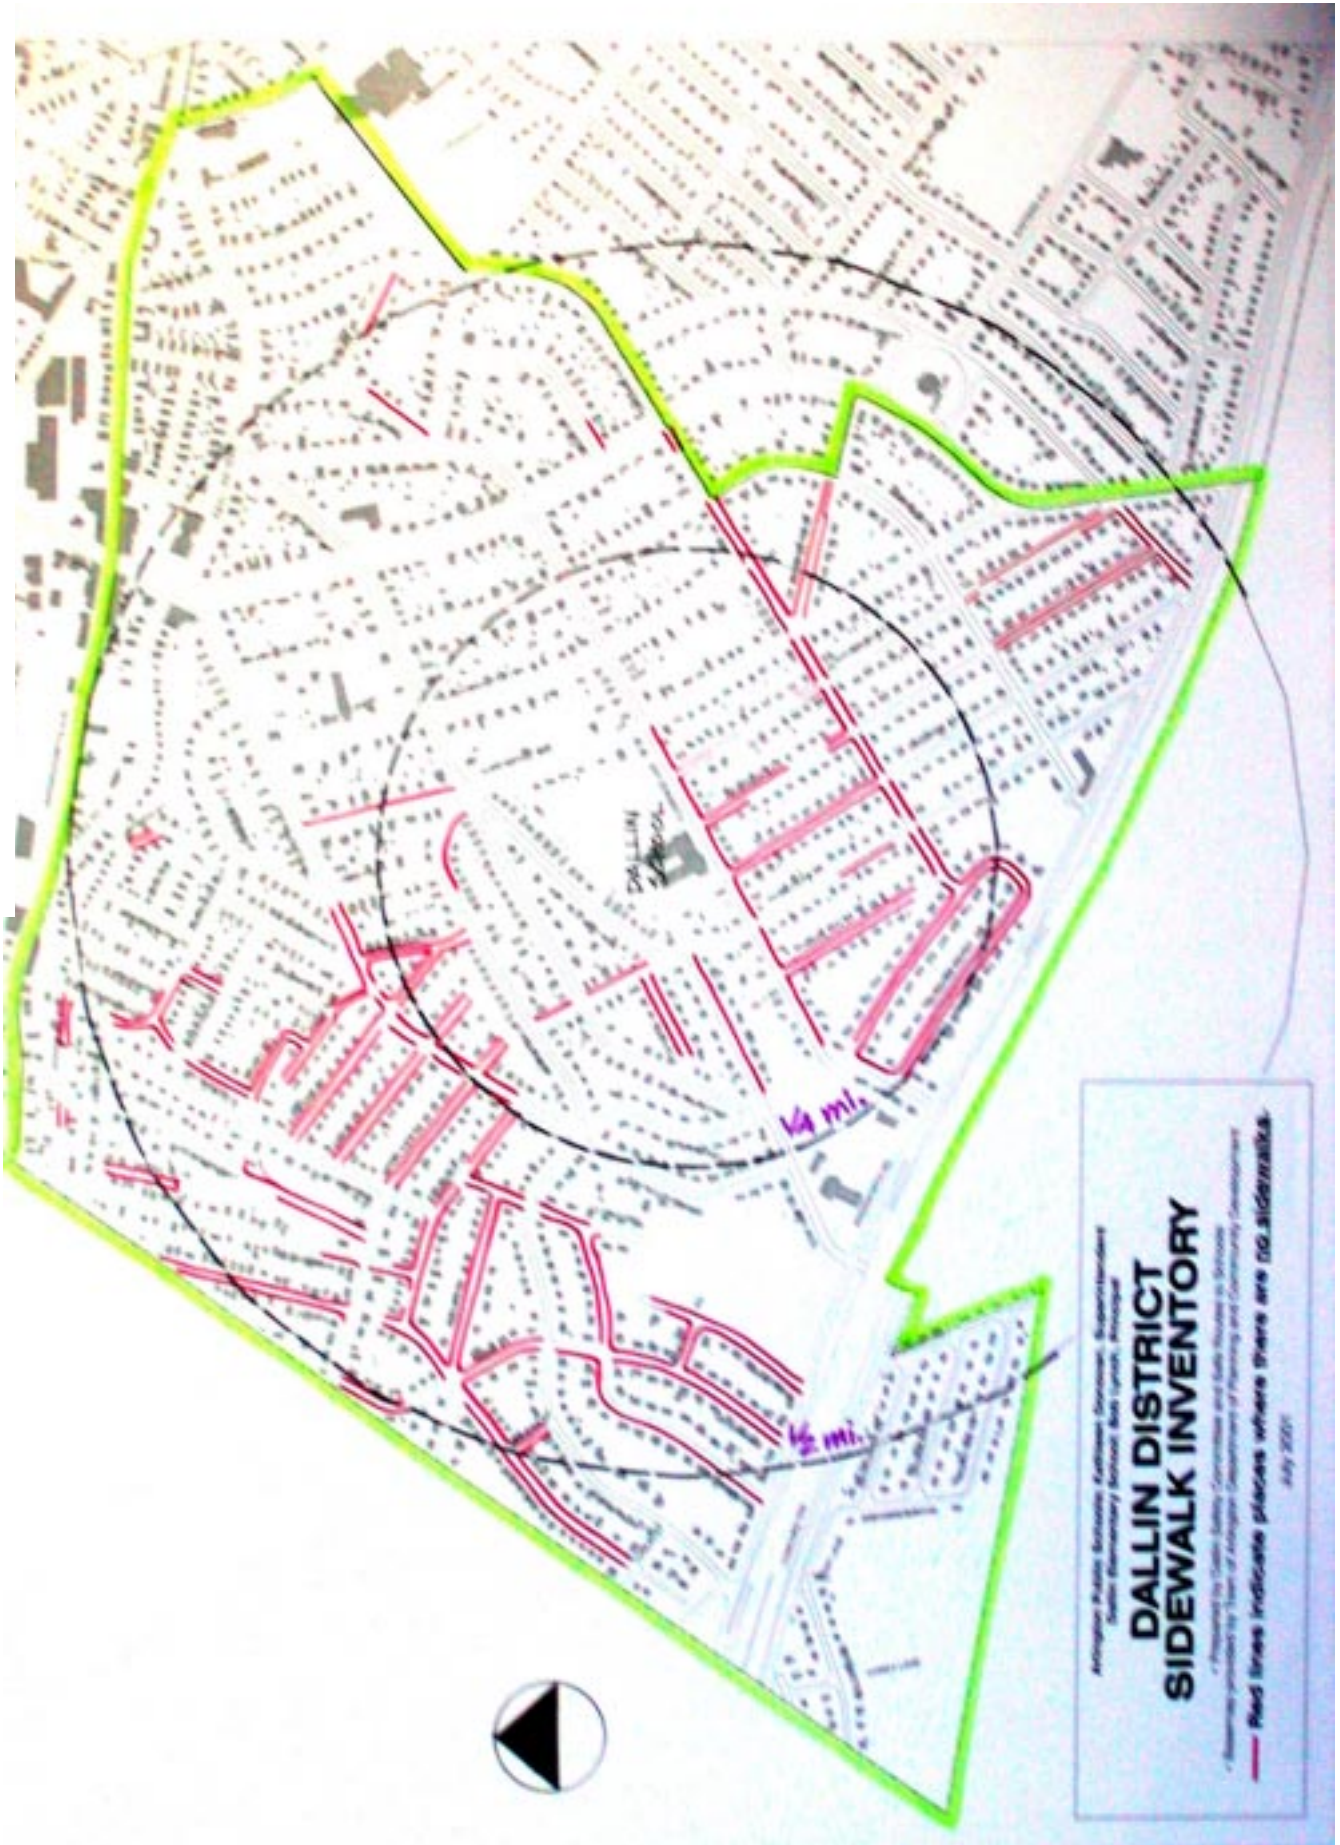
Dallin Area Sidewalk Inventory (dark lines indicate no sidewalk)
 Produced by Safe Routes to Schools and the Dallin PTO

- No sidewalks on the south side of Florence Avenue (across from school)
- Improper location of crosswalk(s) on Florence Avenue
- Substandard bituminous sidewalk on the north side (park side) of Florence Avenue between the school and Wachusett Avenue

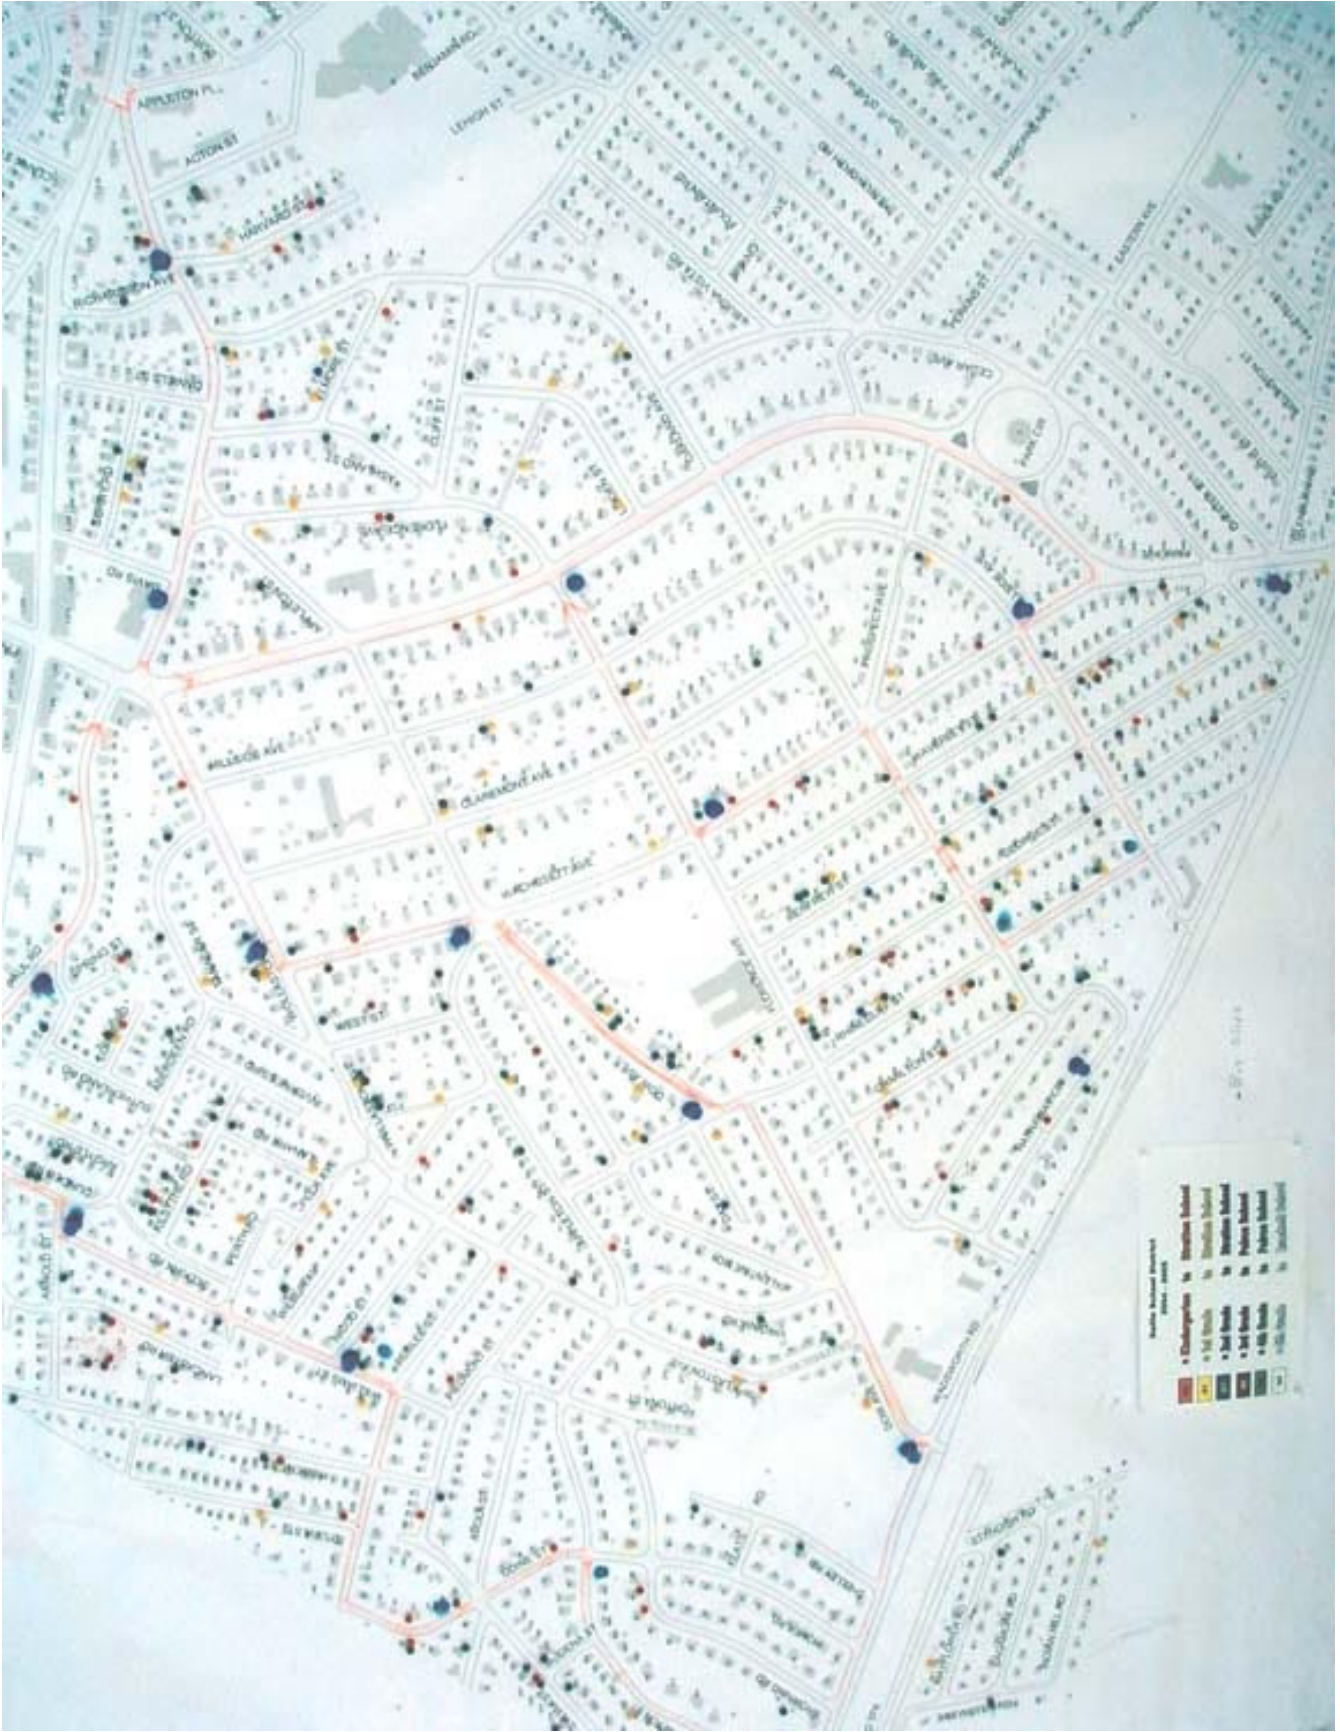
Dallin Student Location Map (dots indicate where students live)
 Produced and maintained by the Dallin PTO
